## **Erosion Testing of Coatings for V-22 Aircraft Applications**#

G.Y. Richardson\*, C.S. Lei\*, and W. Tabakoff\*\*

#### **Abstract**

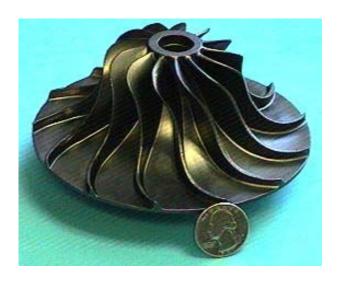
Fig. 1 Photographs of a scrap SDC titanium alloy impeller coated with Surmet's hard carbon erosion resistant coating.

layered coatings was reported as 25.8 GPa and 206 GPa, respectively. In addition, coating process was demonstrated on a Ti-based impeller as shown in Fig.1.
